# Manhole Inspection Summary

Manhole # S35KK\_033MH

Insp Date: **3/13/07 12:11 PM**

**Location** Address: **30 NORTH AVE**

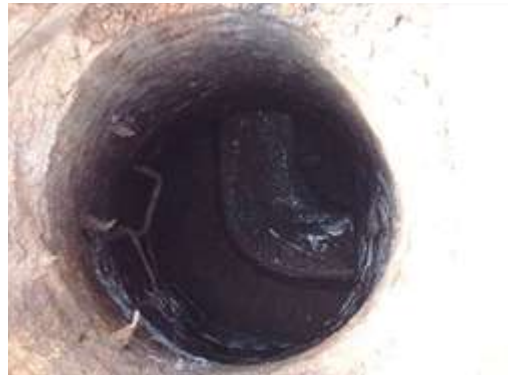
Top View

**Steps** Count: **6** Missing: **2** ☒ **Corroded**

**Surcharge** ☒ **Evidence Of Surcharge** Depth: **3** (ft.) ☐ Active Surcharge Present

Corroded and missing steps. Evidence of surcharge - Bench debris.

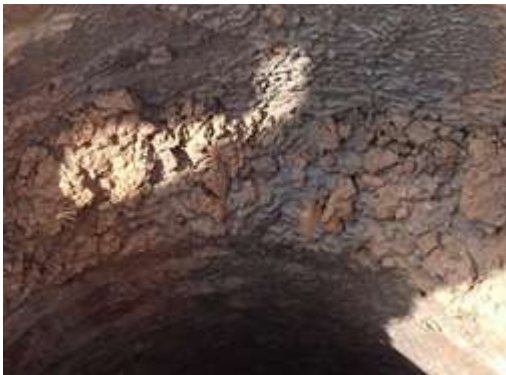
Defect

**Frame** Offset: **4** (in.) Condition: ☐ Sound ☐ Cracked ☒ **Leaks**

Frame leaks. Frame offset.

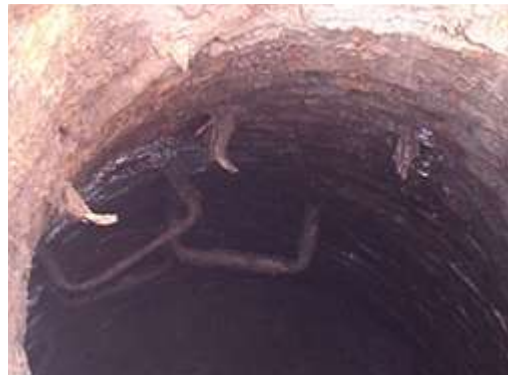
Defect

Condition: ☐ Sound ☐ Cracked ☐ Root Intrusion ☐ Loose Brick ☒ **Deteriorated**

Infiltration: ☐ None ☒ **Joint** ☐ Cracks ☐ Mortar ☐ Roots ☒ **Wall**

Adjustment deterioration and infiltration. Corbel and Barrel infiltration.

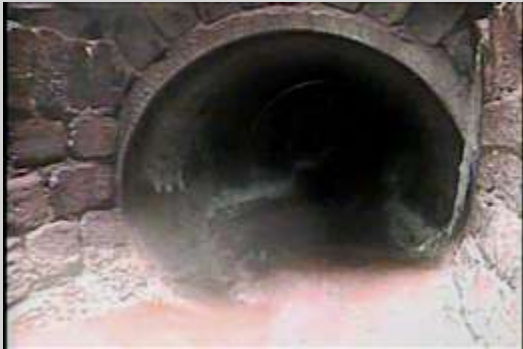
### 18 in. Circular Gravity Sewer Pipe Out @ 12 O'Clock

Channel deterioration.

Deposits: ☐ None ☐ Mud ☐ Sludge ☐ Debris ☒ **Grease**

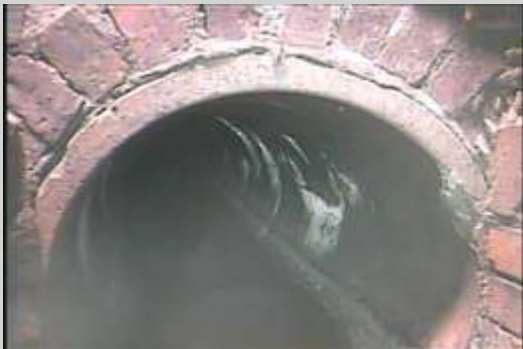
### 18 in. Circular Gravity Sewer Pipe In @ 3 O'Clock

Deposits: ☐ None ☐ Mud ☐ Sludge ☐ Debris ☒ **Grease**
